#### Phytoremediation of Petroleum Hydrocarbon Contaminated Soil in Canada

Elizabeth W. Murray, Bruce M. Greenberg\*, Kent Cryer, Ben Poltorak, Justin McKeown, Jess Spies, and Perry D. Gerwing Earthmaster Environmental Strategies and the \*University of Waterloo

### Predictive Modeling for PHC Remediation

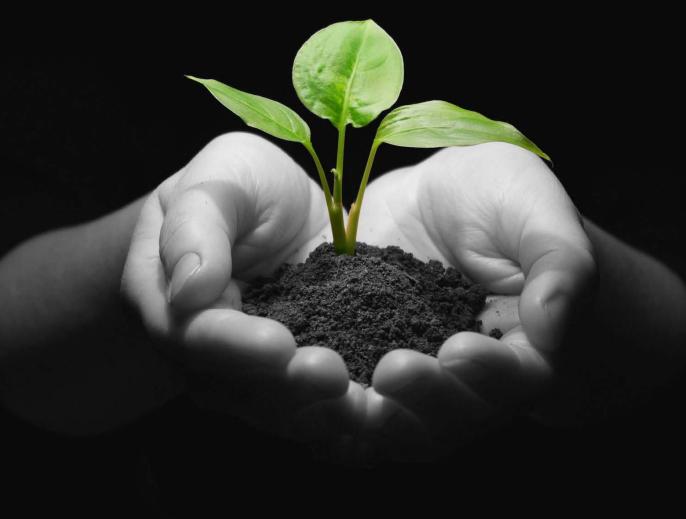
<u>Plant Growth Promoting Rhizobacteria (PGPR) - Enhanced</u> <u>Phytoremediation Systems</u>

- Developed through collaboration between Dr. Bruce Greenberg of the University of Waterloo and Earthmaster for contaminated site clean-up.
- Earthmaster has assumed control of the PEPSystems technology and now manages all PGPR testing, selection, seed treating and overall site specific remediation system design in Calgary. Dr. Greenberg continues to collaborate on PEPSystems.
- The use of specific soil or plant associated microorganisms to enhance plant growth for a variety of applications is gaining popularity due to its effectiveness (agriculture).
- Earthmaster continues to conduct research on how to improve PEPSystems for remediation of contaminated sites or other applications such as to enhance plant growth on marginal or poor quality soils.

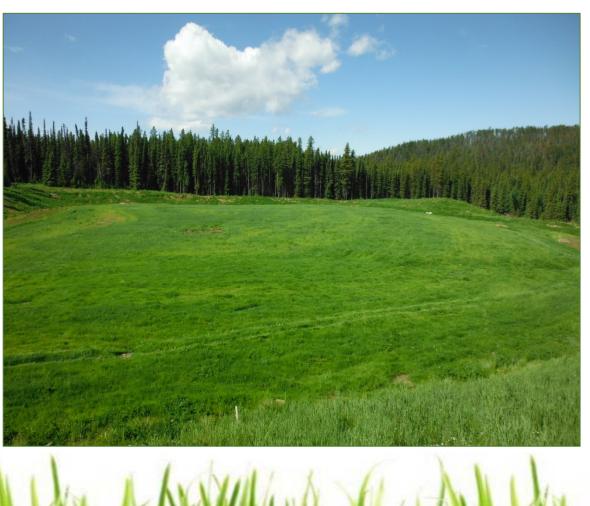
#### Site 1 – West Central Alberta 04-06

Lift #1 Sample Chemistry T = 0						
Donth	РНС	#	Oct 2	2013		
Depth	PHC	samples	range	average*		
0.00-0.25 m	F2	13 of 20	66-830	311 ± 58		
0.25-0.50 m	F2	15 of 20	60-1500	403 ± 75		
#samples exceeding surface soil guideline value *average mg/kg ± standard error						
$150 \text{ mg/kg} \longrightarrow \text{Predicted}$ $150 \text{ mg/kg} \longrightarrow \text{Predicted}$ $1300 \text{ mg/kg} \longrightarrow \text{Predicted}$ $\# \text{ of years}$						
1300 mg/kg		9	0.244

Depth	T=0 C <sub>0</sub>	x yrs	C <sub>1.6 yrs</sub>
0.00-0.25 m	311	1.6	138
0.25-0.50 m	403	2.2	336

Lift #2 Sample Chemistry T = 0							
Donth	epth PHC <sup>#</sup> .		# Nov 20				
Depth	PIL	samples	range	average*			
0.00-0.25 m	F2	7 of 20	21-520	161±30			
0.25-0.50 m	F2	14 of 20	10-1100	417±78

Depth	T=0 C <sub>0</sub>	x yrs	<b>C</b> <sub>0.25 yrs</sub>
0.00-0.25 m	161	0.2	253
0.25-0.50 m	417	2.3	247

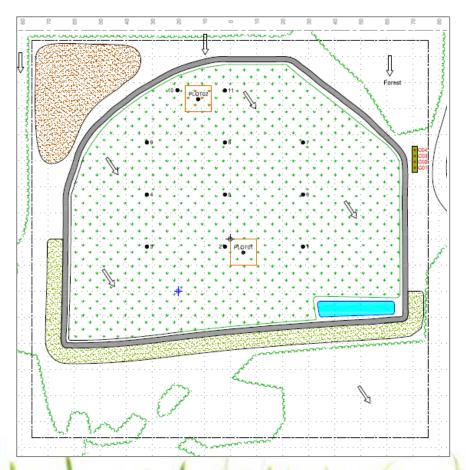
#### Site 2 – West Central Alberta 14-19

12,000 m<sup>3</sup> of material excavated from 2 former DWDAs, wellbore area, and disturbed area were spread to a depth of 1 m:

- Land use natural
- Soil texture fine
- AB remediation guideline values F2:
  - surface soil 150 mg/kg
  - subsoil 300 or 1000 mg/kg
- Seed Arg, Prg, TF
- PGPR Pseudomonas sp.
- Lift #1 T=0 October 2013
  - stripped 4000 m<sup>3</sup> (to 0.25 or 0.50 m depth) in Mar 2016
- Lift #2 T=0 October 2016
  - includes hot spots from lift #1
  - treatment is ongoing

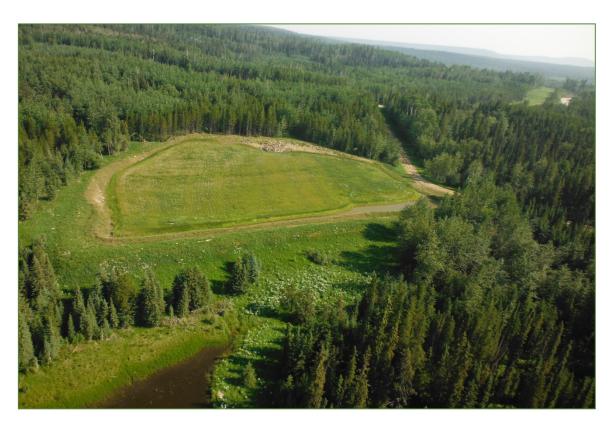
#### Site 2 – West Central Alberta 14-19

Lift #1 Sample Chemistry T = 0						
Donth	РНС	#	Oct	2013		
Depth	PHC	samples	range	average*		
0.00-0.25 m	F2	9 of 11	54-540	310 ± 46		
0.25-0.50 m	F2	9 of 11	41-790	342 ± 76

Depth	T=0 C <sub>0</sub>	x yrs	C <sub>1.6 yrs</sub>
0.00-0.25 m	310	1.6	66
0.25-0.50 m	342	1.8	126

Lift #2 Sample Chemistry T = 0						
Donth	РНС	#	Nov	2016		
Depth	PIIC	samples	range	average*		
0.00-0.25 m	F2	5 of 11	59-790	270±78		
0.25-0.50 m	F2	10 of 11	110-1300	333±102

Depth	T=0 C <sub>0</sub>	x yrs	<b>C</b> <sub>0.25 yrs</sub>
0.00-0.25 m	270	1.3	115
0.25-0.50 m	333	1.8	212

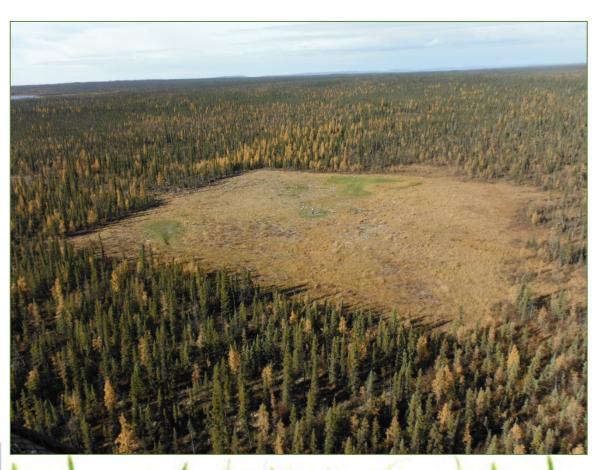
#### Site 6 – NWT C-49

In situ Sample Chemistry T = 0							
рцс	#	Jul 2013					
PIL	samples	range average					
F2	1 of 3	10-600	208±196				
F2	2 of 3	25-2400	858±772				
	PHC F2	PHC # samples F2 1 of 3	PHC # Jul 2 samples range F2 1 of 3 10-600

Depth	T=0 C <sub>0</sub>	x yrs	<b>C</b> <sub>1.0 yrs</sub>
0.00-0.25 m	208	0.7	55
0.25-0.50 m	858	3.9	10

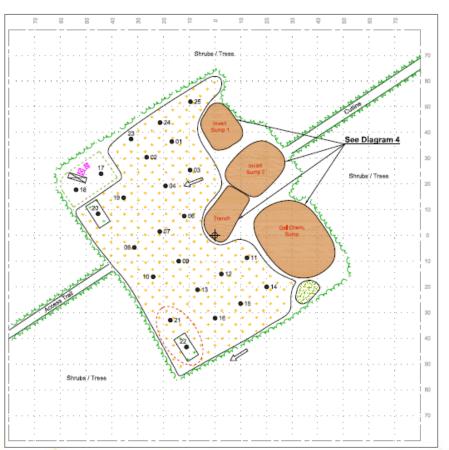
#### Site 7 – NWT C-17

Approximately 5,800 m<sup>3</sup> of material excavated from former pits and sumps onsite to be treated for PHC contamination resulting from historical drilling activities:

- Land use industrial
- Soil texture course
- CCME remediation guideline values F2:
  - surface soil 260 mg/kg
  - subsoil 320 mg/kg
- Seed Arg, Prg, TF
- PGPR Pseudomonas corrugata and P. marginalis.
- Lift #1 T=0 June 2008
  - Surface soil treated for salt and PHC.
  - Completed in July 2011 and left in place.
  - Additional material excavated and placed on top of Lift #1 for treatment.

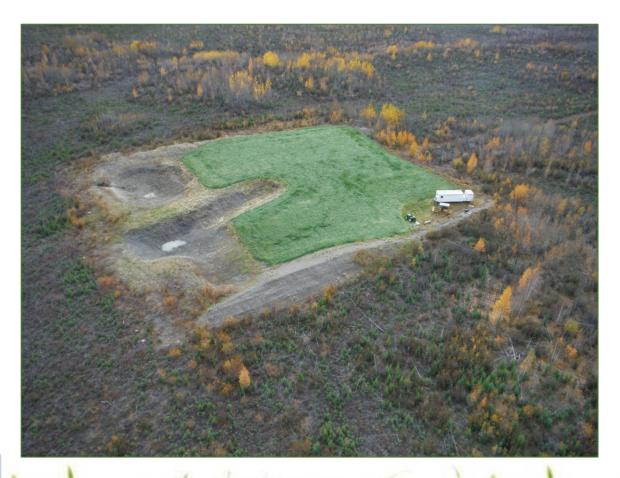
#### Site 7 – NWT C-17

Depth	Depth T=0 C <sub>0</sub>		C <sub>2.0 yrs</sub>	
0.00-0.30 m	549	1.7	84

Lift #3: 900 m<sup>3</sup> spread on lift #2. Treated for F2 contamination.

Depth	epth T=0 C <sub>o</sub>		C <sub>2.1 yrs</sub>	
0.00-0.30 m 1417		3.8	275

Lift #4: 1,600 m<sup>3</sup> spread on Lift #3. Treated for F2 contamination and 1250 m<sup>3</sup> stripped in June 2017.

Depth	T=0 C <sub>0</sub>	x yrs	C <sub>0.3 yrs</sub>	
0.00-0.30 m	644	2.0	360

Lift #5: 350 m<sup>3</sup> mixed with 750 m<sup>3</sup> of additional soil. Treated for F2 contamination starting June 2017.

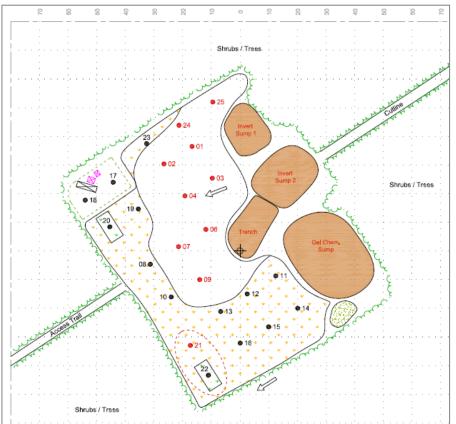
#### Site 7 – NWT C-17 Challenges

Lift #4 Sample Chemistry T = 0								
Donth	Donth DUC		Jul 2016			Sep 2016		
Depth PHC		# samples	range	average*	# samples	range	average*	
0.00-0.30 m	F2	23 of 25	57-1350	644±73	12 of 25	50-802	360±45
